# Manhole Inspection Summary

Manhole # S25E\_\_028MH

Insp Date: **8/9/07 10:20 AM**

**Location** Address: **1301 SARATOGA ST**

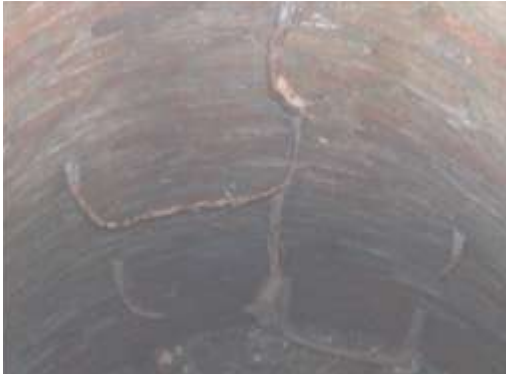
Defect 3

Count: **2** Missing: **3** ☒ **Corroded**

CORRODED STEPS AND MISSING

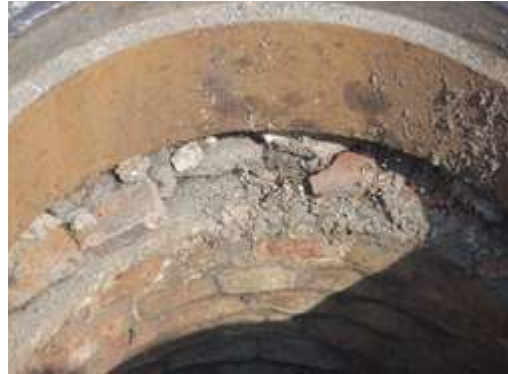
Defect 2

Condition: ☐ Sound ☐ Cracked ☐ Root Intrusion ☐ Loose Brick ☒ **Deteriorated**

DETERIORATION OF CHIMNEY ALL  
360 DEGREES

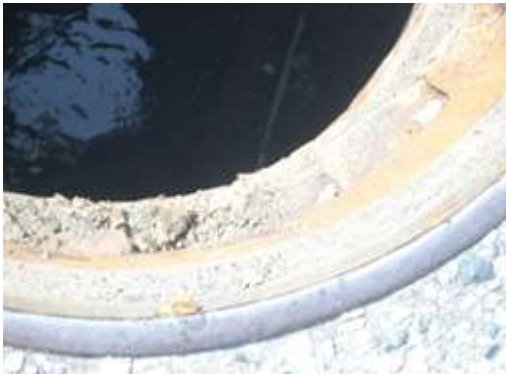
Defect 1

Offset: **2** (in.)

FRAME OFFSET

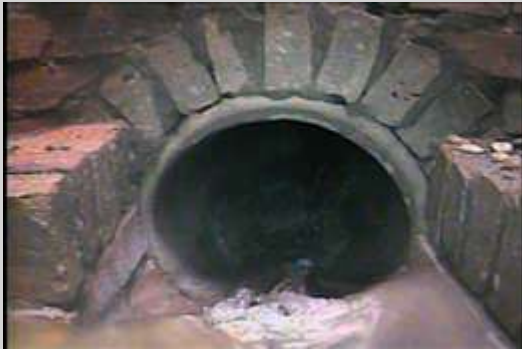
12 O'Clock Outflow

Pipe Height: **12** (in.) Rod and Bar (Angled)  
Pipe Material: **Clay** ☐ Pipe Lined  
Invert Depth: **10.14** (ft.) Flow Characteristics: **Slow**  
Deposits: ☐ None ☐ Mud ☐ Sludge ☒ **Debris** ☐ Grease  
Silt Depth: **2** (in.) Deposits Extent: **Light**  
Infiltration: **None** Pipe Seal Cond: **Sound**

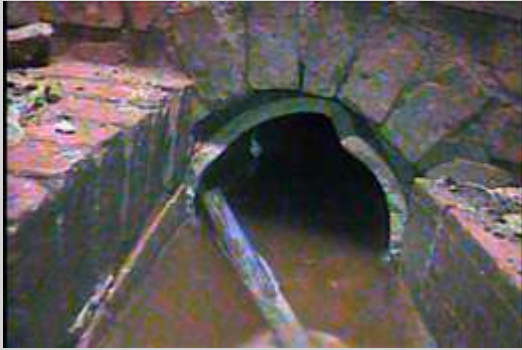
9 O'Clock Inflow

Deposits: ☐ None ☐ Mud ☐ Sludge ☒ **Debris** ☐ Grease

Silt Depth: **3** (in.) Deposits Extent: **Medium**

Infiltration: **None** Pipe Seal Cond: **Broken**
